Executive Summary:

Site/Project Location: Trenton terminal/Trenton ND

Date of Inspection: 1 November 2016

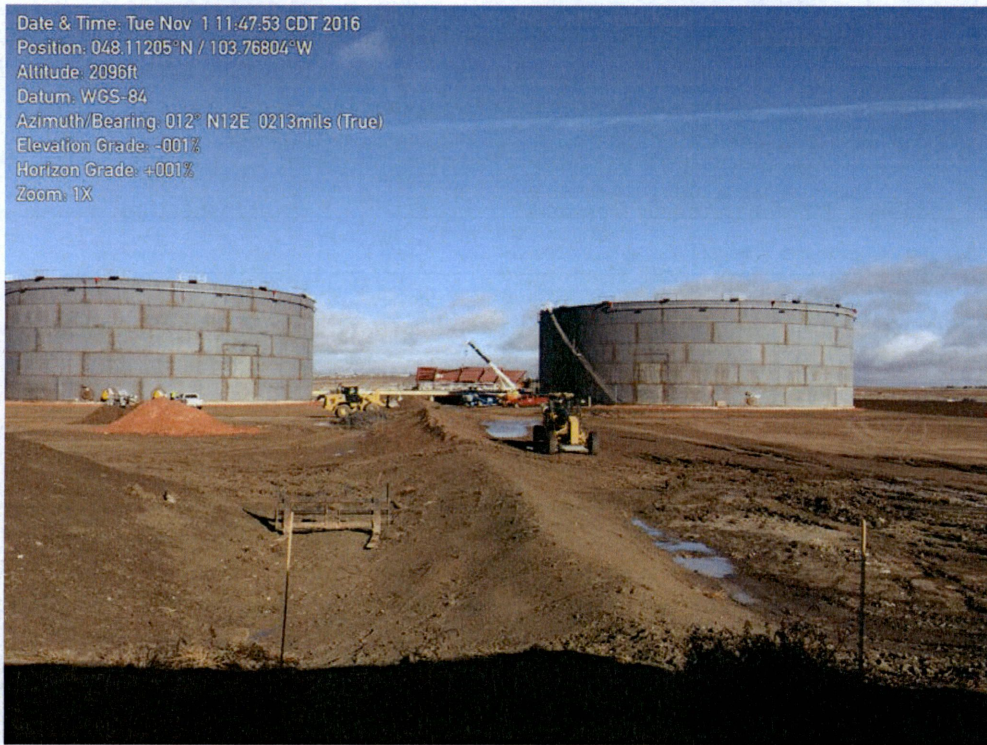
Report Photo #1 "Tanks and On-Going Construction":

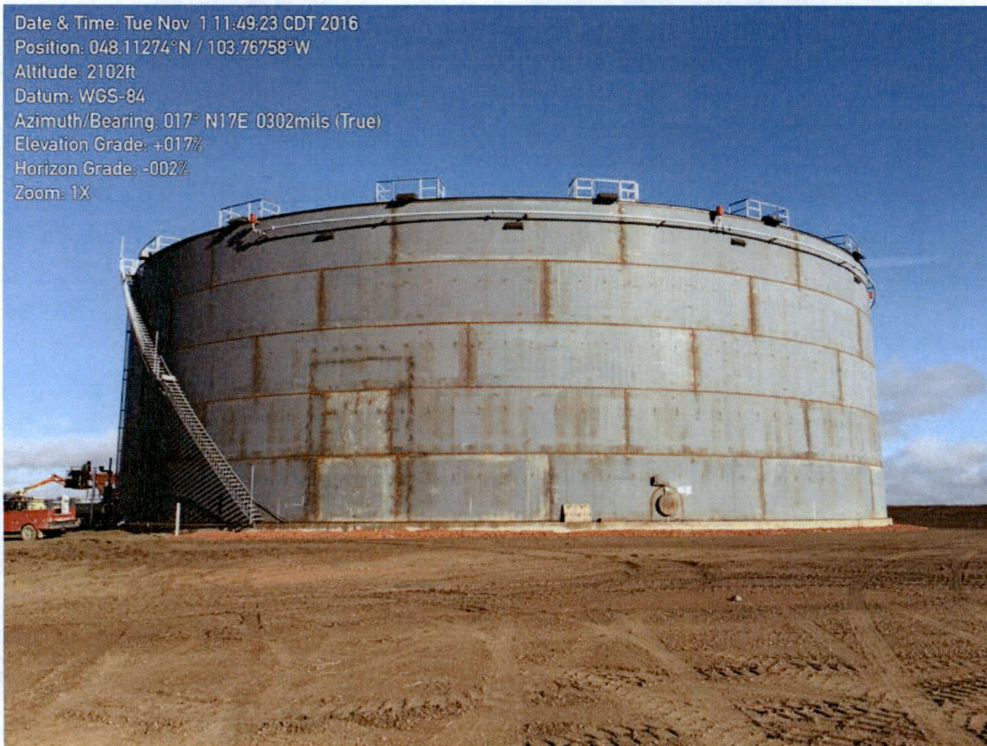
Report Photo #2 "Tank"

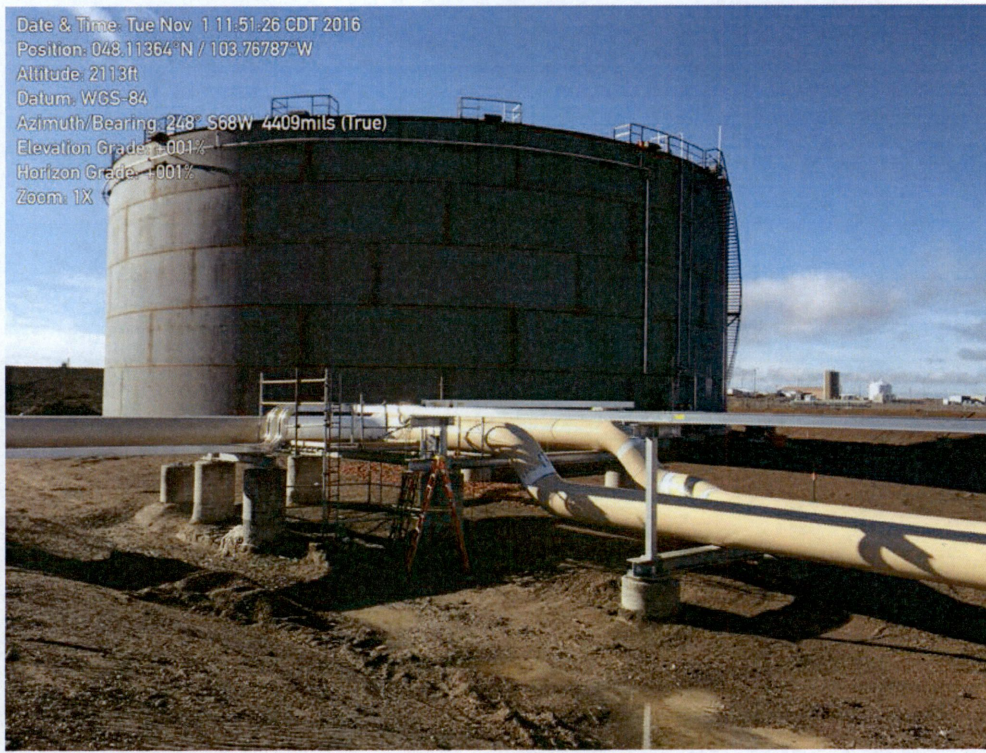
Precision Pipeline has finished constructing piping to tanks. Rose Rock is the first of three client pipelines connected at this time.

Report Photo #3 "Piping to Tank"
